## WAIKIKI BANYAN

Manager's Update:

October 08, 2020

# WB DW&V /Spall Projects & Building Maintenance

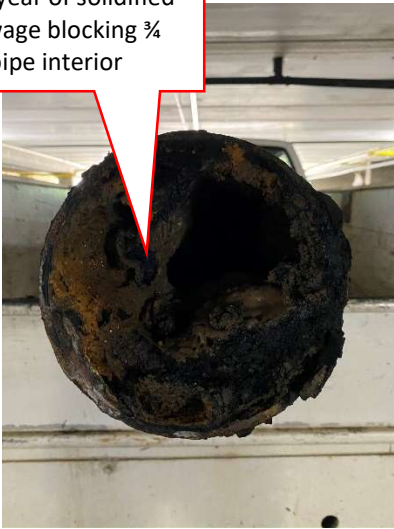
42-year of solidified sewage blocking ¾ of pipe interior

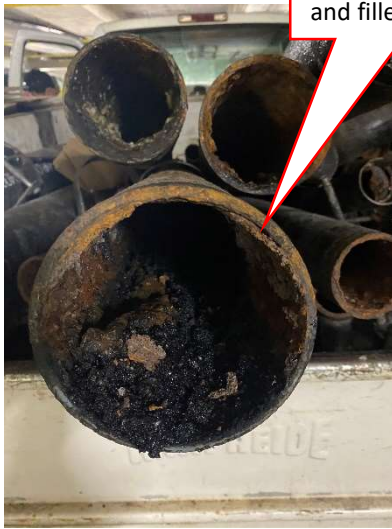
Pipe walls corroded and filled with debris

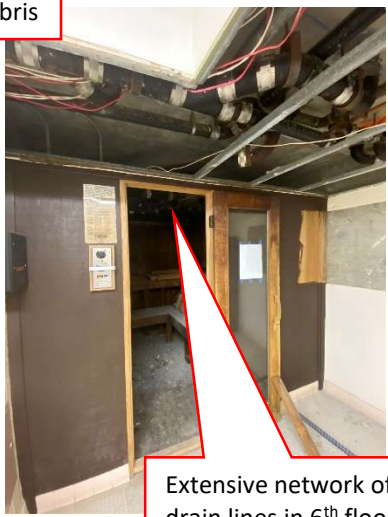
Extensive network of lateral drain lines in 6th floor men's sauna and shower area ceiling. Sauna will require rebuild

- The men's sauna will be unavailable until the completion of the pipe project unless a third-party contractor is hired to reinstall. Inhouse staff do not have the resources until the pipe project is completed.

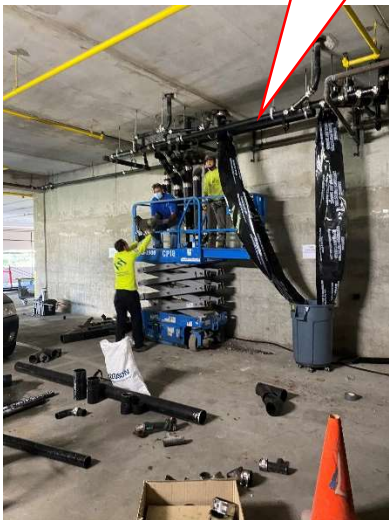
5th floor garage webbing work

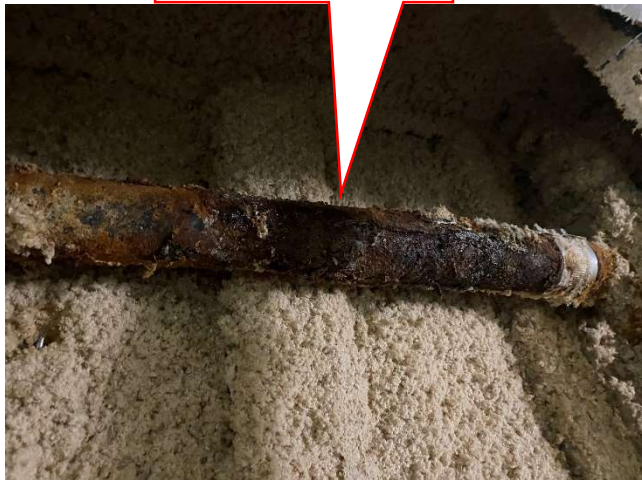
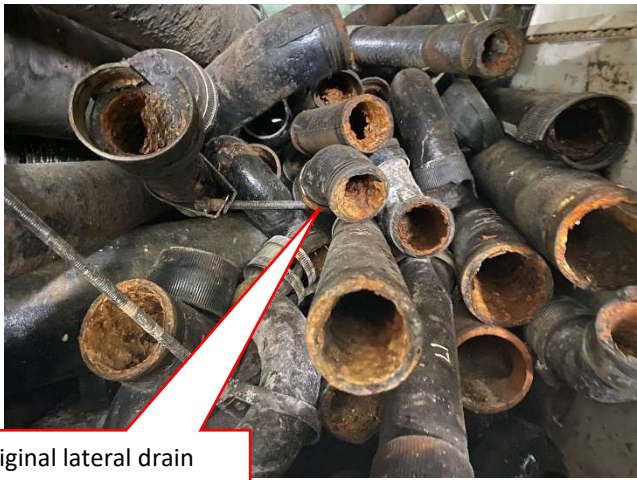
Lateral drain lines that had active leaks were found on every floor

Original lateral drain and vent lines

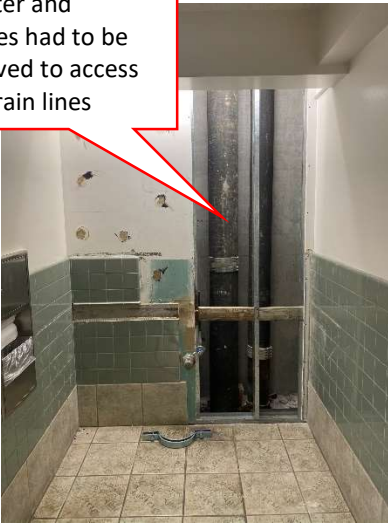
2<sup>nd</sup> floor bathroom. Counter and fixtures had to be removed to access the drain lines

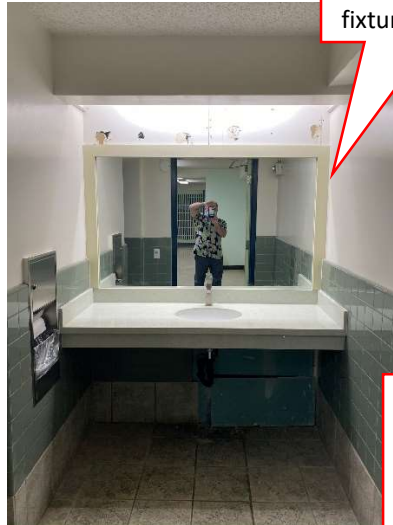
2<sup>nd</sup> floor bathroom with new countertop and fixture & mirror

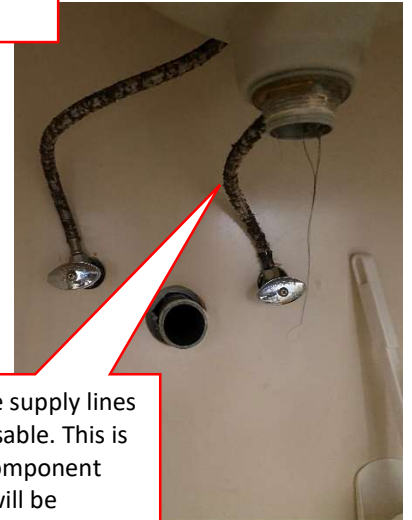
Unit fixture supply lines found unusable. This is a critical component item that will be replaced

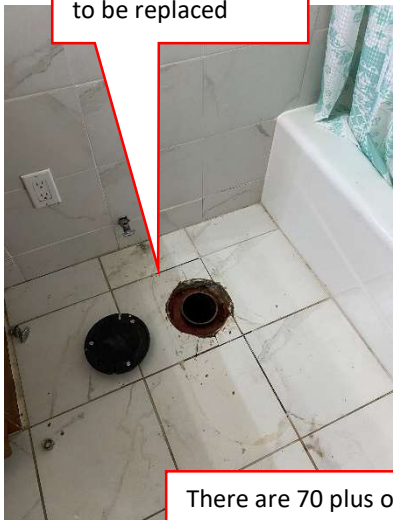
Typical toilet flange to be replaced

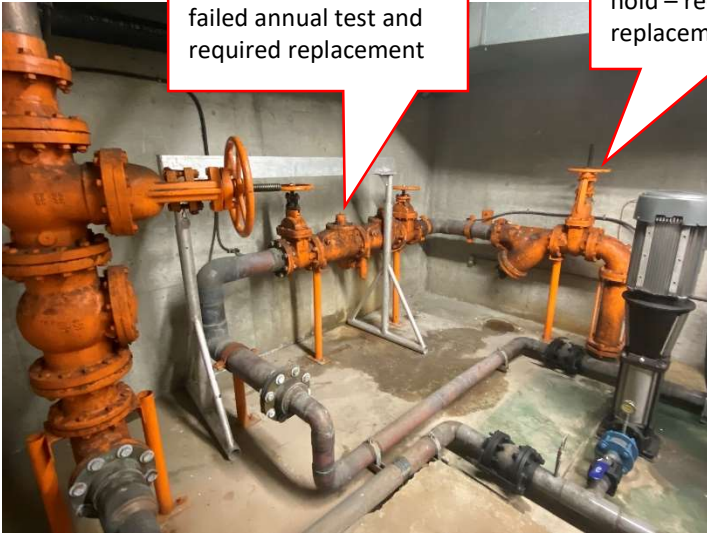
Back flow preventor failed annual test and required replacement

New Wilkins Back flow preventor

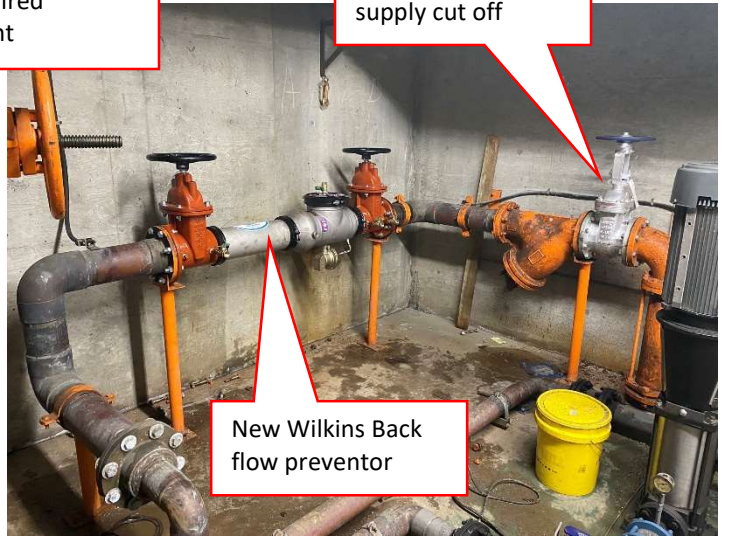
Main water supply isolation valve did not hold – required replacement

New 6" Main supply cut off

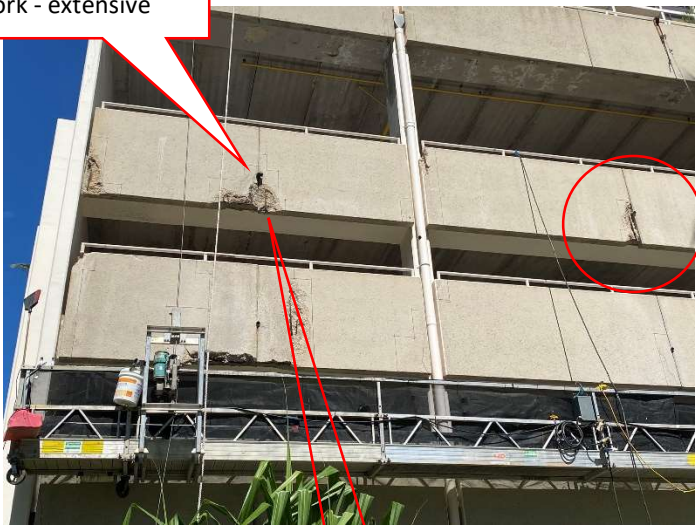
Paoakalani Spall work - extensive

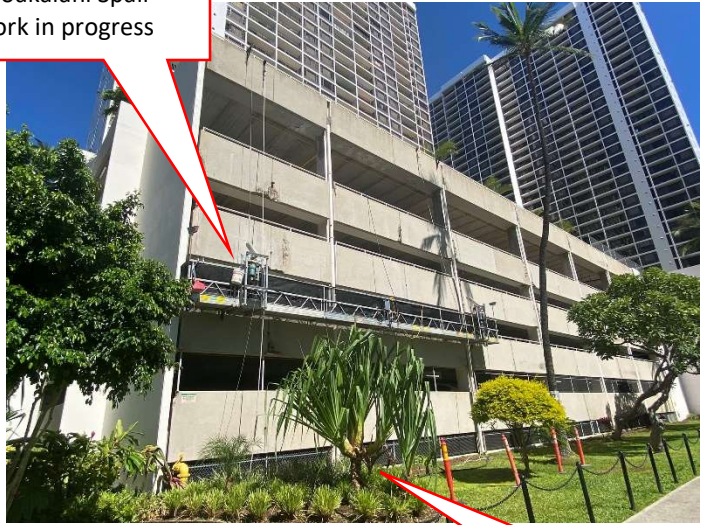
Paoakalani Spall work in progress

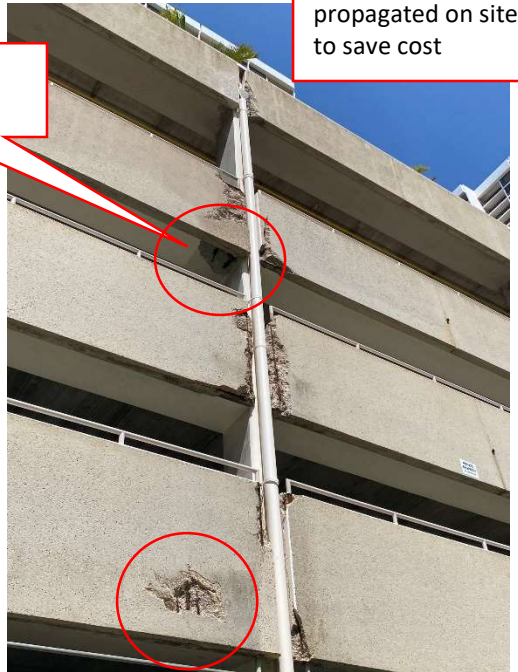
Structural Beam Spall

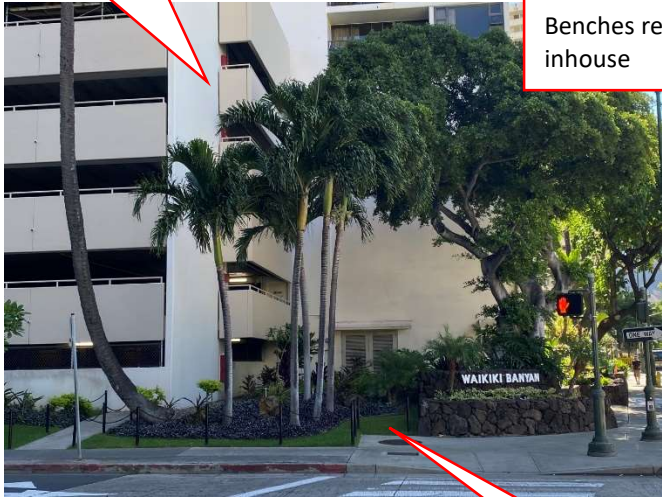
Completed spall and painting of garage drop 1 - 7
